# Manhole Inspection Summary

Manhole # S39G\_\_026MH

Insp Date: **7/14/08 11:33 AM**

**Location** Address: **866 E Lombard ST**

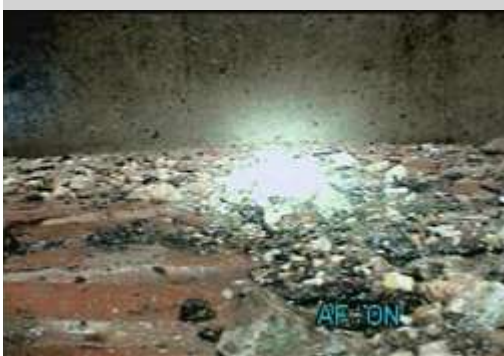
Defect 5

Condition: ☐ Sound ☐ Cracked ☐ Root Intrusion ☐ Deteriorated ☐ Leaks ☒ **Debris**

debris

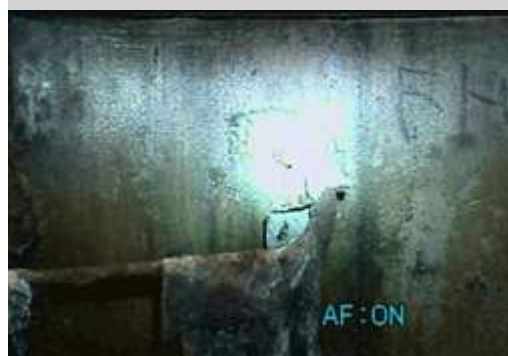
Defect 3

**Surcharge** ☒ **Evidence Of Surcharge** Depth: **9.** (ft.) ☐ Active Surcharge Present

evidence of surcharge

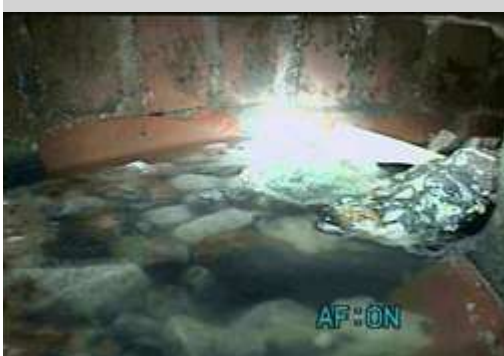
Defect 2

channel debris

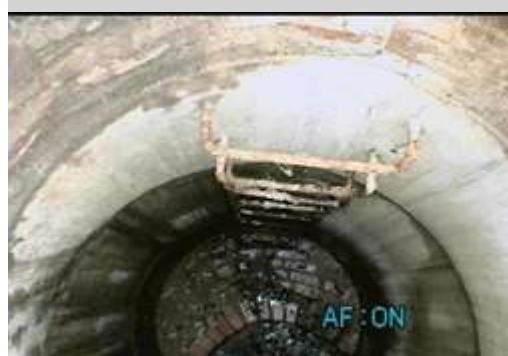
**Steps** Count: **9** Missing: **0** ☒ **Corroded**

steps

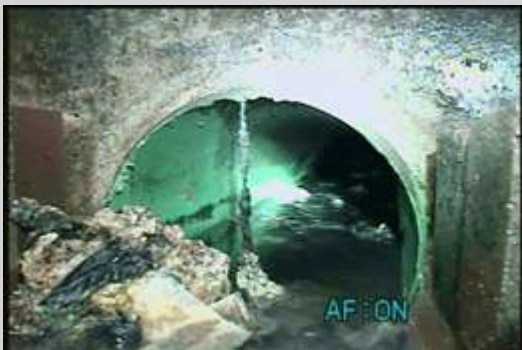
12 O'Clock Outflow

8 in. Circular Gravity Sewer  
Pipe Out @ 12 O'Clock

Deposits: ☐ None ☐ Mud ☐ Sludge ☒ Debris ☐ Grease

Silt Depth: 3 (in.) Deposits Extent: Light

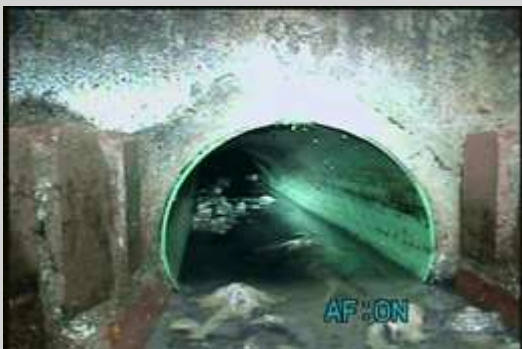
3 O'Clock Inflow

8 in. Circular Gravity Sewer  
Pipe In @ 3 O'Clock

Deposits: ☐ None ☐ Mud ☒ Sludge ☒ Debris ☐ Grease

Silt Depth: 3 (in.) Deposits Extent: Light
